# Genisys Repair Strategies:

Using the Genisys Scan Tool with the plug-in Lab Scope Module to quickly solve a hard-to-find intermittent miss problem that only occurred under load.

**Vehicle:** 1999 Ford E150 Conversion Van

**Engine:** 5.4 V-8 with coil-on-plug system

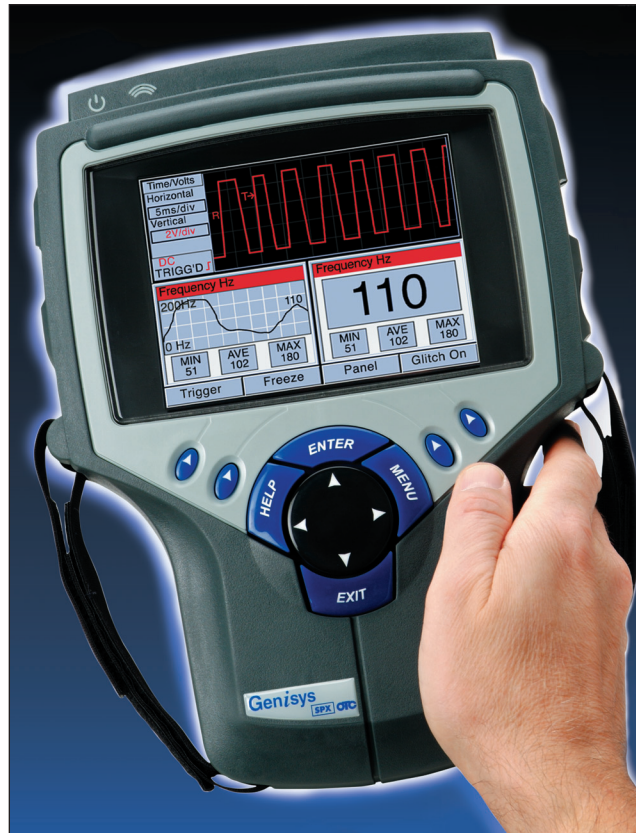
Once again on my road test, when the miss occurred I hit the record button. The playback file showed Coil #3 shorting out. I had located the problem—actually Genisys gets all the credit. Due to the design of this van and engine, and its aftermarket rear heater, I had to remove the engine cover to replace the coil. That turned out to be harder than the diagnosis!

right side of the engine (Bank 1). My next step was to back-probe the circuits for each of the four coils on Bank 1, at the PCM, using the Genisys Lab Scope.
